# Grant Brandal<sup>1</sup>

# Y. Lawrence Yao

# Material Influence on Mitigation of Stress Corrosion Cracking Via Laser Shock Peening

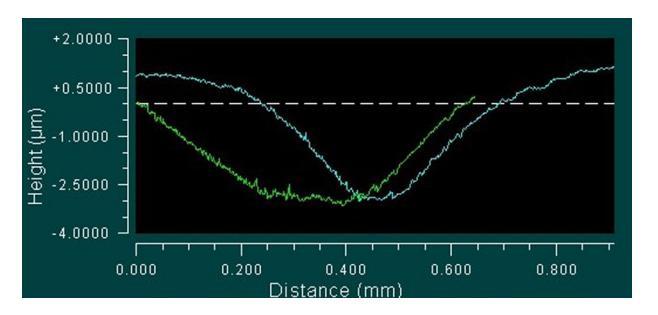
Fig. 1 LSP indentation profile of a stainless steel sample irradiated at 250 mJ with a spot size of 0.9 mm. The two lines are traces across perpendicular directions.

Surface Morphology. Characterization of the surface morphology is first performed to understand the impact the LSP treating had on the surfaces. Figures 1 and 2 show optical profilometer measurements across LSP indentations, where the two lines are measured in perpendicular directions. Figure 1 is a stainless steel sample irradiated at 250 mJ showing indentation depth of slightly over 3  $\mu$ m. As compared to the stainless steel sample, a brass sample processed with the same parameters has a similar depth, but it is clear that the roughness within the indentation is much higher on the brass. Much more surface deformation has occurred, such as the emergence of large slip bands, and this result could be potentially harmful to the brass. Increased surface roughness provides the corrosive environment more cracks and crevices to penetrate into, and as such, smoother surfaces are generally more corrosion resistant. But it is important to keep in mind the scale of this roughening. The indentations on the stainless are large and smooth enough that they should not cause any detrimental effects such as crevice corrosion or local acidification of the electrolyte. As the laser scans across the surface, it creates a uniform array of

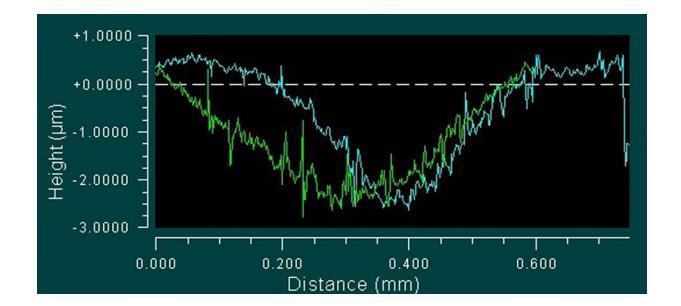
Fig. 2 Indentation profile of brass LSP processed at 250 mJ. More surface roughening effects are visible than on the stainless steel sample.

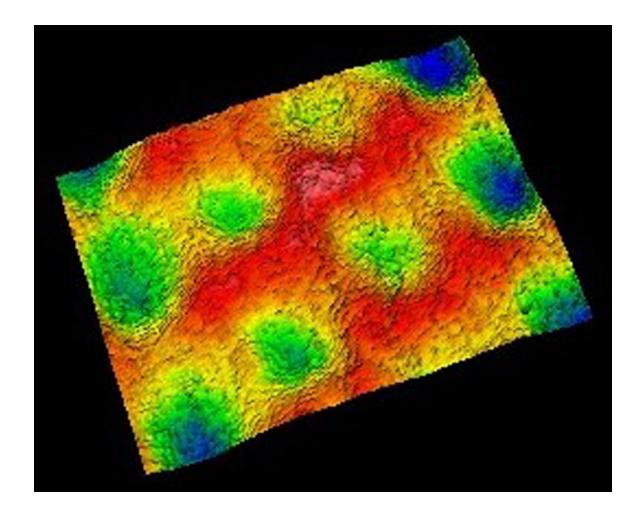
Fig. 3 Morphology of a patterned brass sample after LSP processing. Individual indentations are still visible because of the 0% overlap condition.

indentations, of which a 3D topographical map is shown in Fig. 3 for a brass sample. This pattern is for 0% overlapping between adjacent pulses, and good uniformity of the surface indentations is seen across the samples.

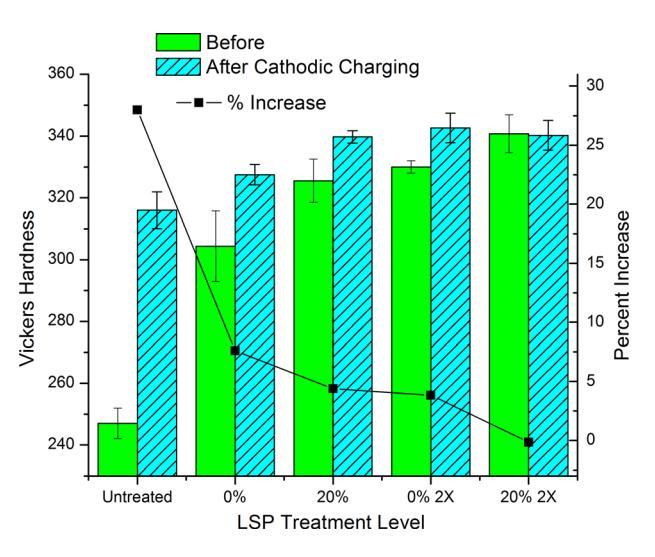
Fig. 4 Hardness increases after cathodic charging on stainless steel samples, caused by increased hydrogen absorption into the lattice. The values on the abscissa correspond to the amount of overlapping between adjacent LSP pulses, and 2X indicates that the surface was treated with two passes. As the level of LSP processing increases, the amount of hardness changes via hydrogen decreases.

Hardness increases induced by cathodic charging of stainless steel samples and 4140 high strength steel are plotted in Figs. 4 and 5, respectively. Vickers hardness (HV) is determined by the equation

where L is the applied indenter load in grams, and d is the observed diagonal length. Based on this relationship, and using our applied load of 100 gf, we can estimate that for HV = 300 the indentation reached about 5  $\mu$ m into the sample, indicating that by using the low indenter load we are measuring in the near-surface regions that would experience the LSP effect. Five different processing conditions are shown where the hardness for each respective treatment level is plotted before and after cathodic charging. With increasing amounts of laser processing, there is a clear decrease in the amount of hardness increase by cathodic charging. For untreated stainless steel samples, cathodic charging caused nearly 30% hardness increases, while all of the LSP treated samples underwent less than 10% increases, with the increase becoming statistically insignificant for the samples processed at 20% and two passes. The high strength steel shown in Fig. 5 underwent lower percent increases from both LSP and cathodic charging, but show the same trend as for stainless steel. As this material is much less ductile than stainless steel, the 10% hardness increase in the untreated sample could still have significant detrimental effects.

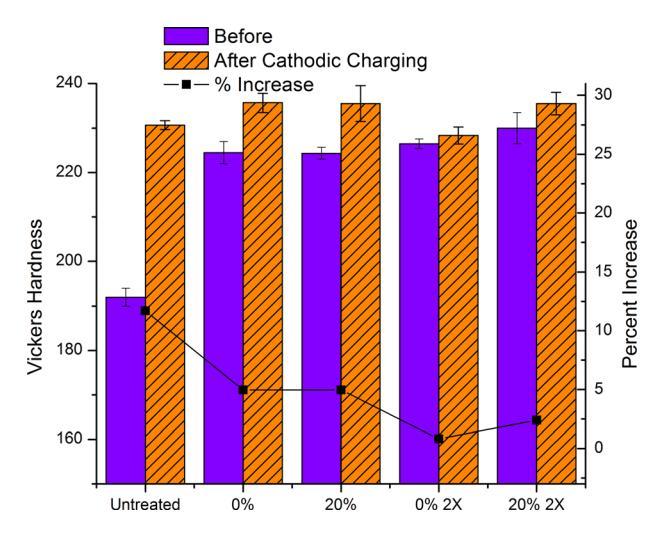
Fig. 5 Hardness increases of AISI 4140 steel after cathodic charging. The level of LSP processing causes the hydrogen effects to be lessened, indicating mitigation to hydrogen embrittlement. The percent increases are lesser than for the stainless steel show.

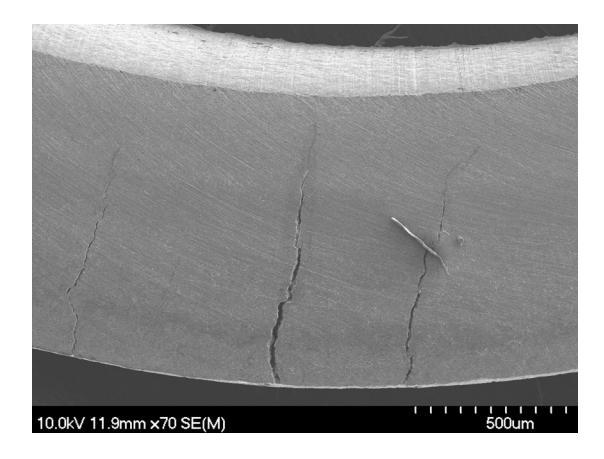
Fig. 6 SEM micrograph of the side of an untreated stainless steel U-bend specimens after 1 h of exposure to boiling magnesium chloride

An image of the fractured surface of an untreated stainless steel sample is shown in Fig. 6. In this, the samples were exposed to a boiling magnesium chloride solution for precisely 1 h, and then removed regardless of observing failure or not. In this way, comparisons can be made showing the benefits of LSP at a snapshot in time. A dominant large crack can be seen in the center of Fig. 6, nearly propagating through the entire thickness. Two other minor cracks are also evident. The large cracking did not occur on LSP treated samples after the 1 h MgCl<sub>2</sub> exposure, but some smaller crack initiation was found. While the sides of the specimens were not LSP treated, the cracking appears to initiate on the outer surface (bottom edge of images) which is the side that LSP processing was executed and also where the highest levels of tensile stress occur. At the edge of the sample, if the crack begins propagating across the outer surface, catastrophic failure will be inevitable.

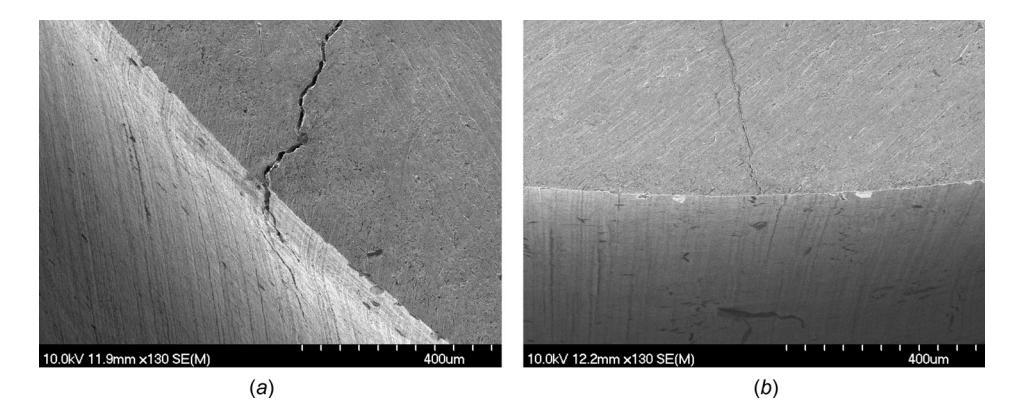
Fig. 7 Untreated (a) and LSP treated (b) images showing the edge of stainless steel U-bend samples, where the bottom part of these images is the outer surface. LSP prevents cracks from propagating onto the outer surface in (b).

On the untreated sample in Fig. 7(a), it is clear the propagation does occur in both directions, as this figure is taken at an angle showing both the side and the outer face of the sample. In the treated samples, as seen in Fig. 7(b), the crack is prevented from

propagating down the front, LSP treated surface. This effect of preventing existing cracks from propagating onto the LSP treated surface is most likely the result of the compressive stress induced by the processing. Even though these samples are in tension because of the U-bending, having an initial compressive stress lowers the amount of tensile stress found in the final form [6]. Furthermore, not only does LSP treating prevent crack propagation, but it also prevents the formation of cracking, as illustrated in Fig. 8. This image is of the outer surface of an untreated sample, showing that after 1 h of magnesium chloride exposure cracks begin to form. Conversely, no initiation was found on the LSP treated samples. While the mechanical compressive stress definitely plays a role, other factors to be discussed later become nearly as significant.

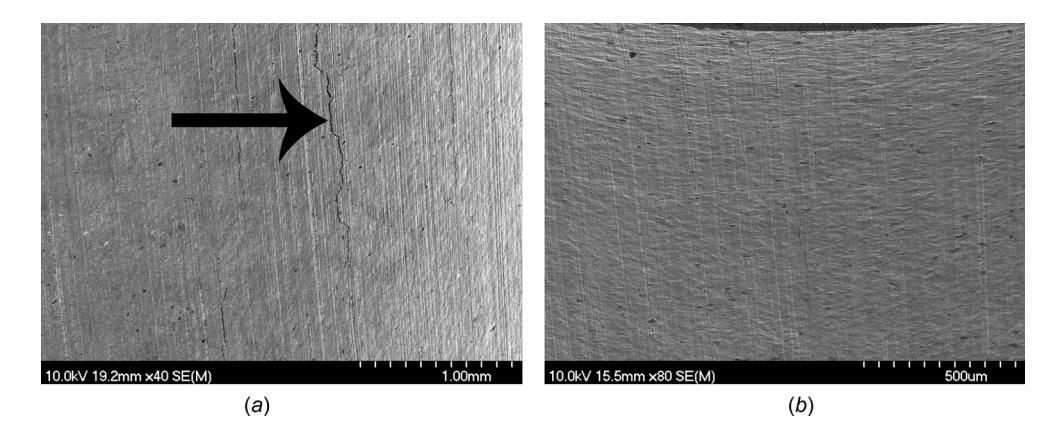
Fig. 8 Outer U-bent face for untreated stainless steel samples. Indicated by the arrow, cracking has occurred for the untreated sample, but was been prevented from occurring on the LSP treated sample.

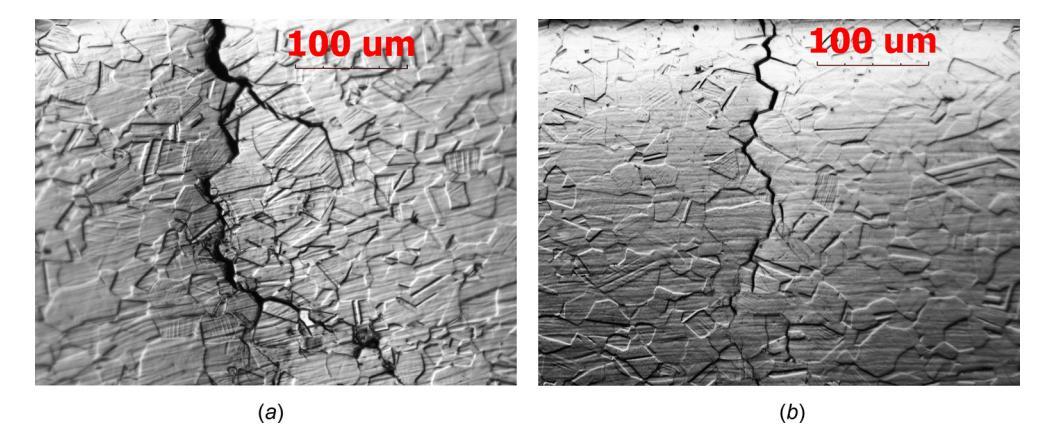
Fig. 9 Optical micrographs of etched stainless steel samples exposed to 1 h of boiling magnesium chloride. (*a*) has not been LSP treated, and shows a combination of transgranular and intergranular fracture. (*b*) has been LSP treated, where the fracture mechanism is now dominated by intergranular fracture. The effects of increased hydrogen penetrating the lattice in (*a*) may cause the transgranular failure.

Etching the fractured surface enables examination of the failure type differences between the untreated and treated samples, which can be seen in Fig. 9. The untreated samples have both large intergranular cracking and many smaller branches with transgranular failure characteristics. Conversely, the treated samples showed only intergranular failure without the occurrence of branching. The differences in fracture mode should be considered while remembering that hardness increases suggest the presence of more hydrogen in the untreated samples than the treated ones. Hydrogen's presence within the grains may effectively reduce their fracture toughness, via hydrogen enhanced decohesion, allowing cracks to propagate directly through these weakened grains. Processing by LSP has also been shown to increase the grain size uniformity [26]. Since nonuniformity will result in the stress not being evenly distributed across grains, certain grains in non-LSP treated samples may be at increased risk to failure, and thus suffer from transgranular failure.

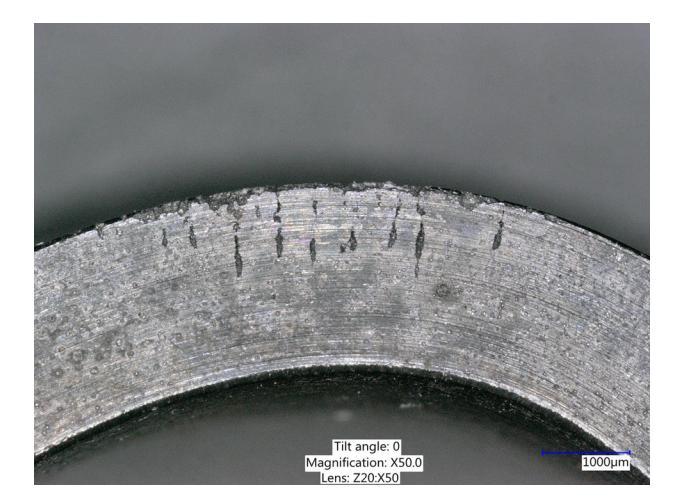
Fig. 10 Multiple cracks found in an AISI 4140 U-bend sample LSP three times at 300 mJ. Unlike the stainless steel, the high strength steel fails by many parallel cracks rather than one major failure.

the stainless steel failing by a single catastrophic crack propagating, many adjacent cracks formed simultaneously in the high strength steel samples, as seen in Fig. 10. The different SCC mechanisms can be attributed with this variation. Passive layer breakdown is often cited as a cause of SCC failure in stainless steel. Once a particular location fails in the stainless steel, it is reasonable that sudden, localized failure will occur in the region, particularly if the underlying lattice has been weakened by hydrogen absorption. Conversely, the high strength steel does not have the protective oxide layer, which is why simultaneous failure may occur across larger regions.

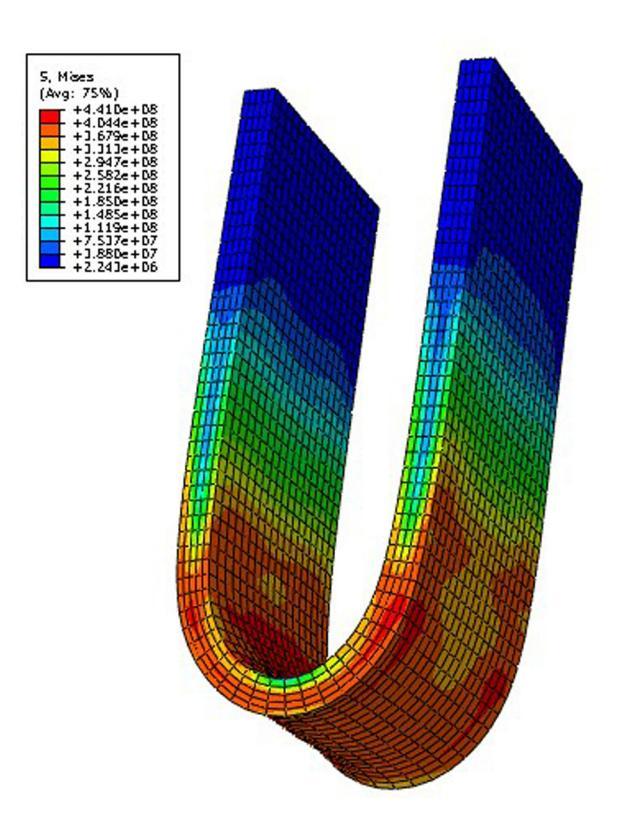
Fig. 11 Mises stress in Pascals overlaid on the final deformed shape of a U-bend specimen from FEM simulation

A finite element model was used for estimating the levels of stress in each of the U-bend samples. Even though the bend geometry is the same for the stainless steel and brass (4 mm radius of curvature), their yield strengths and strain hardening result in differences. Figure 11 shows a 3D representation of the final geometry of a bent specimen overlaid with Mises stress, where it can be seen that the highest stress magnitudes occur at the bottom and along the sides. Tensile stress causes SCC, and a plot showing the tension on a path along the center of the outside (bottom) face is shown in Fig. 12. The peak stress experienced by the brass samples is nearly 100 MPa higher than that of the stainless steels, owing to the higher ductility of the stainless steel, and subsequently more plasticity occurring in the brass. Since both of these levels are above the material's yield strengths, dislocation generation from forming the U-bend does occur, potentially interacting with LSP's effects and increasing the total amount of dislocations available for hydrogen trapping. This suggests that U-bend samples with lower induced stress would see even larger relative mitigation improvement from LSP processing.

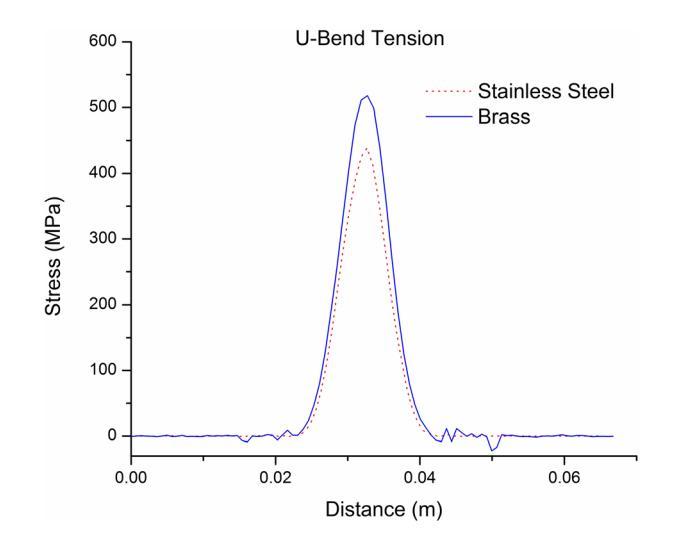
Fig. 12 Tension on a path along the long direction in the center of the U-bend samples. The peak stress is higher for the brass.

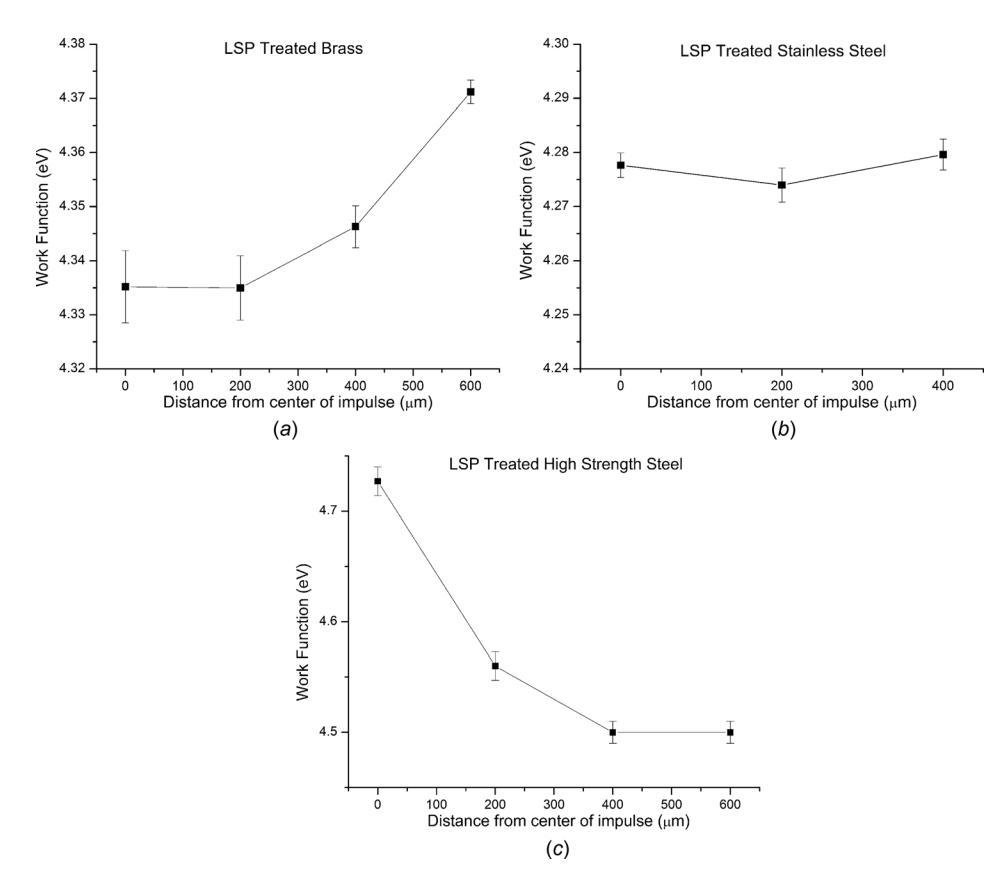
Fig. 13 Work function measurements for brass, stainless steel, and high strength steel. The center of the LSP pulse is at 0  $\mu$ m, and each material changes differently in response to the incident shockwave. Brass experiences work function decreases from LSP, while the high strength steel experiences an increased work function. The scale on the high strength steel figure covers a wider range than the other two, indicating an increased response to the shockwave processing.

Kelvin Probe Force Microscopy. For each of the three materials tested, the effect on work function from LSP processing is shown in Fig. 13, where the x-axis plots the radial distance outward from the center of a single incident laser pulse. The incident laser has a radius of about 500  $\mu$ m, where beyond this the material is considered as untreated. Since increases in work function are associated with increases in corrosion rest potentials, ideally there would be increased work functions in the processed areas. But upon initial inspection of the figure, it is clear that each of the materials behave differently. High strength steel does show an increase in work function, suggesting improved corrosion resistance, which corresponds to the improvement found in the U-bend testing. But brass actually decreases in the laser processed area while the stainless steel shows essentially no change in work function. These different responses can be explained by exploring fundamental differences of the three materials.

Even though the dislocation generation in stainless steel is expected to be similar to the high strength steel, Fig. 12(b) shows no change in the work function as a result of LSP. As for the brass, the activation of slip systems and dislocation generation that occurs for the stainless also occurs, but the major factor contributing to stainless that is absent from the brass is the presence of a thick surface oxide layer. Stainless's chromium oxide layer greatly impacts the work function, so any of the reduced work function regions in the bulk of the material may be concealed by the oxide layer. Compressive stresses also promote oxide layer growth, another benefit of the LSP process. In this way, LSP processing of the stainless steel may exhibit only the beneficial effects because the oxide layer works to suppress any detrimental material imperfections.

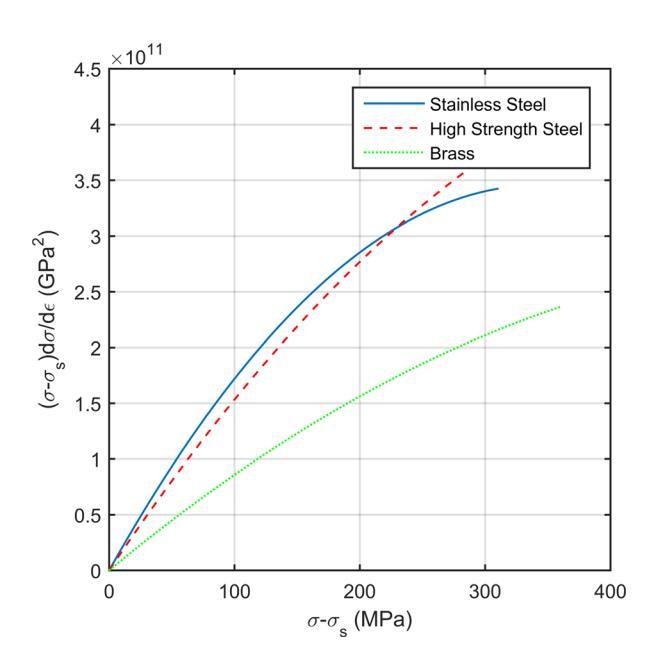
Fig. 14 Rate of change of dislocation density, on the vertical axis for, varying amounts of plastic deformation. The three materials generate dislocations at varying rates. But since the yield strength of high strength steel is the largest, it will have lower dislocation generation for a given amount of deformation.

Plotting Eq. (5) for our three materials of interest is shown in Fig. 14. The values on the ordinate axis are proportional to the dislocation density, showing how the two types of steel initially behave similarly and the brass is distinctly different. Upon plastic deformation, the high strength steel develops dislocations at a much faster rate than the brass. But for given deformations, the high strength steel actually will have fewer dislocations because of its much higher yield strength (675 MPa versus 360 MPa). Laser shock peening imparts a compressive residual stress in the materials, and in order for the high strength steel to be capable of having an increased work function, this compressive stress must outweigh the detrimental effects of increased dislocation density. Contrasting this is the brass, where the lower yield stress allows for more plastic deformation, and thus larger increases in

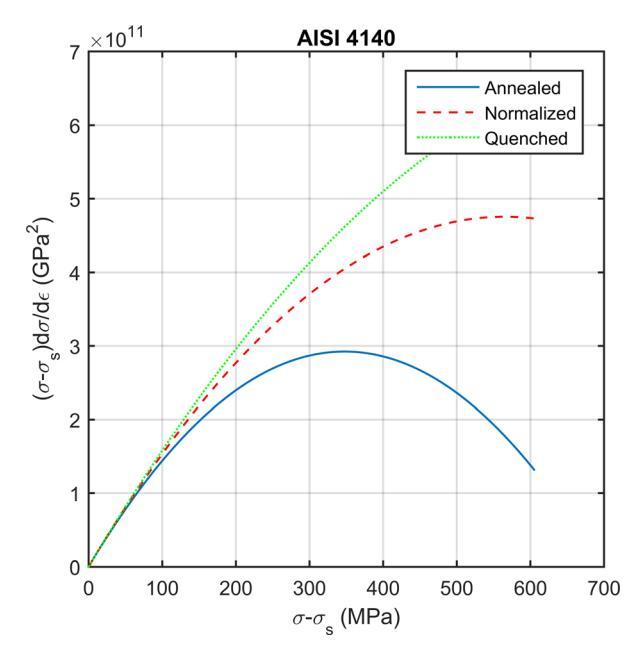
Fig. 15 Rate of change of dislocation density for high strength steel with three different types of heat treatments. As such, the downward slope of the annealed sample above 350 MPa does not indicate decreasing dislocation density but rather that dislocations are being generated at a slower rate.

dislocation density. Prior heat treatments will also affect the rate at which dislocations are generated in a material. Figure 15 shows the rate of dislocation generation for annealed, normalized, and quenched high strength steel. It can be seen that annealing, resulting in the highest ductility, results in the slowest rate of dislocation generation. For implementing LSP to mitigate SCC, it is thus important to take the thermal history of the target material into account.
